## Addendum

### Request for Proposal – Environmental Abatement for Rolla Public Library 908-910 N. Pine Street Properties

## Asbestos Building Inspection Report

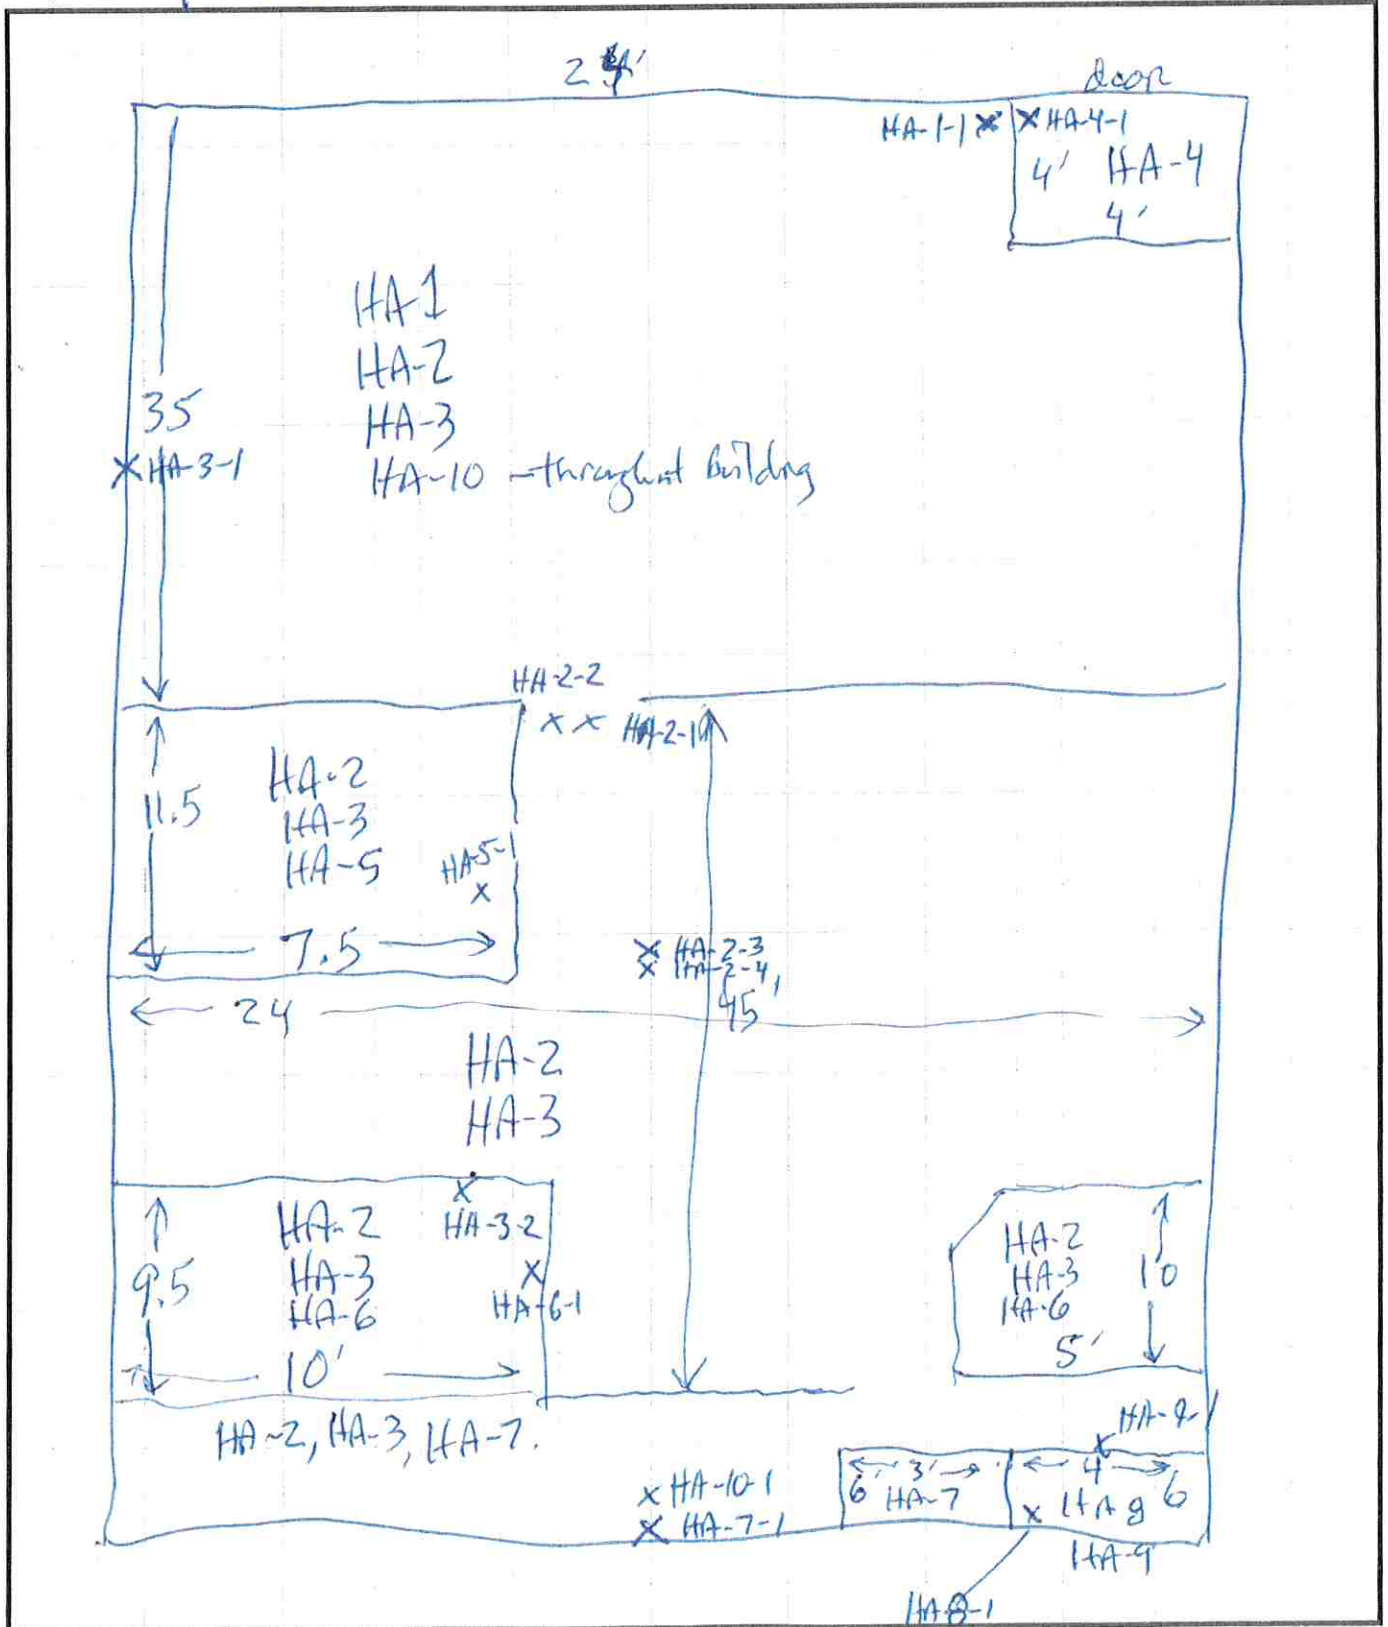
Subject: 908 N. Pine      Date: \_\_\_\_\_      Sheet: \_\_\_\_\_ of \_\_\_\_\_

Samples were collected from each of the eleven homogenous areas and the locations of each of the samples are identified on my site map. All the materials were in relatively good condition.

- HA-1 gray carpet & mastic
- HA-2 white/brown tile & mastic
- HA-3 drywall & tape compound
- HA-4 brown tile & mastic
- HA-5 greenish carpet & mastic
- HA-6 orange carpet
- HA-7 Brown tile
- HA-8 tan linoleum
- HA-9 cement block
- HA-10 ceiling tile
- HA-11 Roof samples

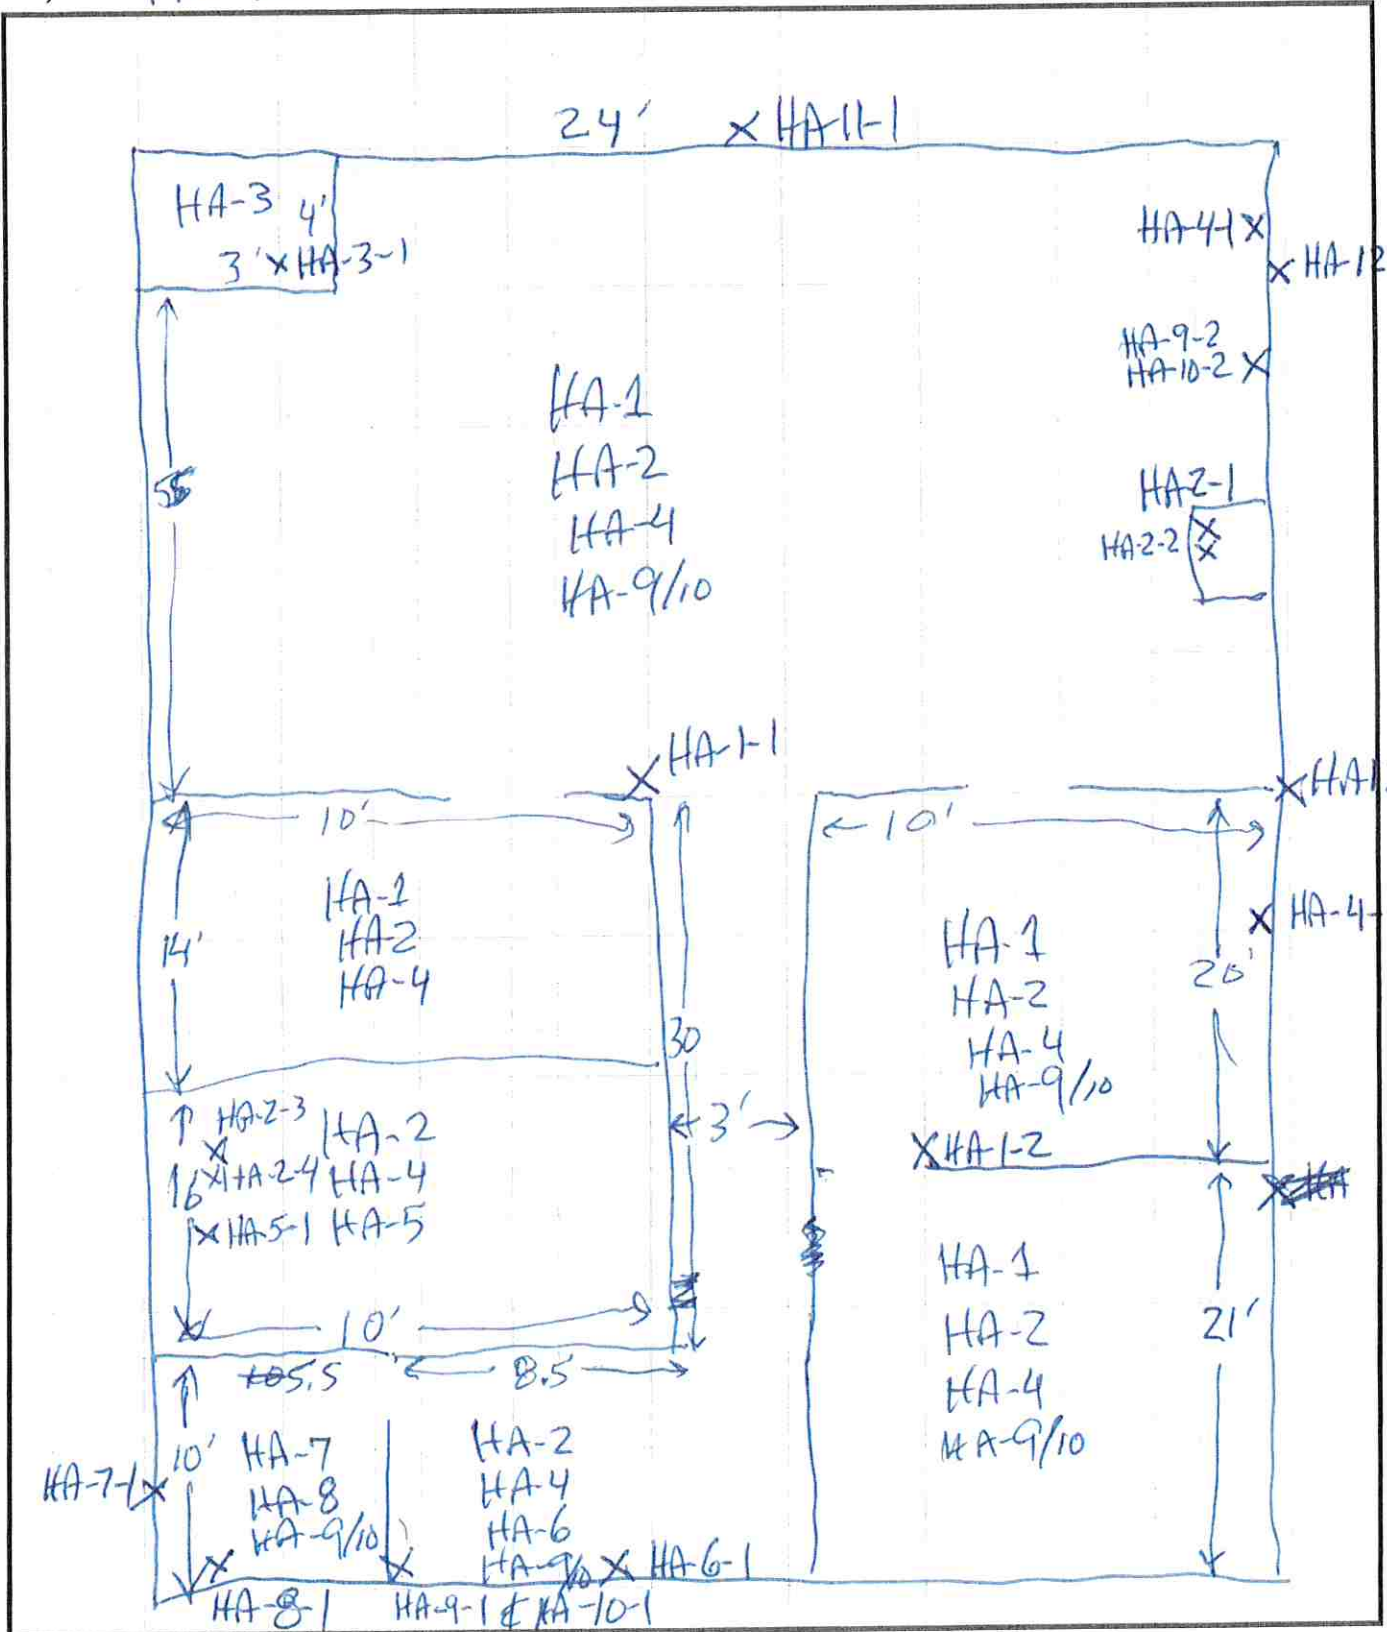
Subject: 910 N. Pine

| HA-1 | Blue carpet & mastic |
| HA-2 | white/brown tile & mastic |
| HA-3 | Brown tile & mastic |
| HA-4 | Dry wall / tape compound |
| HA-5 | Green carpet & mastic pad |
| HA-6 | Brown carpet & mastic |
| HA-7 | green wall tile & grout |
| HA-8 | gray tile & mastic |
| HA-9 | Cement (yellow) block |
| HA-10 | grout for yellow cement block |
| HA-11 | front building grout |
| HA-12 | side building grout |
| HA-13 | new side building grout |
